White Paper

*To Plan the Renovation of Philbrook Museum of Art's HVAC System*

Philbrook Museum of Art

Submitted March 31, 2019

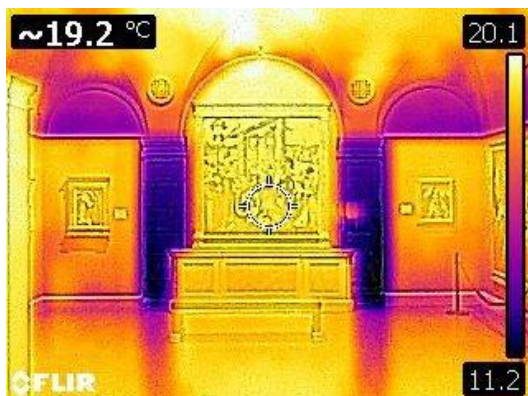
Photo 1 (left): Thermal image of the Kress Gallery, the columns appear purple, indicating moisture.

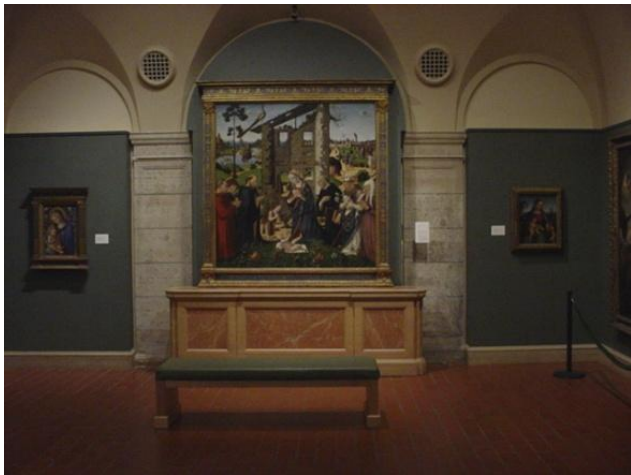
Photo 1

During the November 6<sup>th</sup> tour of the Kress Gallery, staff indicated moisture and mold issues had developed around the SW covered openings of the South Terrace (**Photo 1**). Staff were concerned the aforementioned issues were impacting the displayed artwork on the west wall. After further investigation of this area by de Verges the following issues were identified:

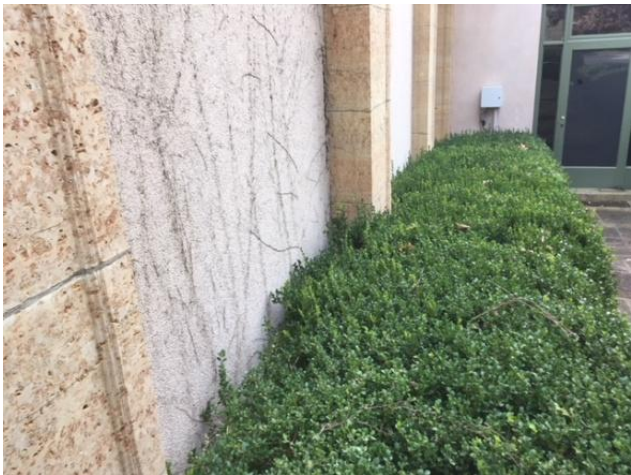
Photo 2

- A. **Sun Room Limestone Columns Observations** - The limestone columns of the sun room are porous due to the indicating dissolution features of the rock and matrix material. The columns (**Photos 2 & 3**) are exposed to moisture from the outdoor environment as well as the villa irrigation system. During our site

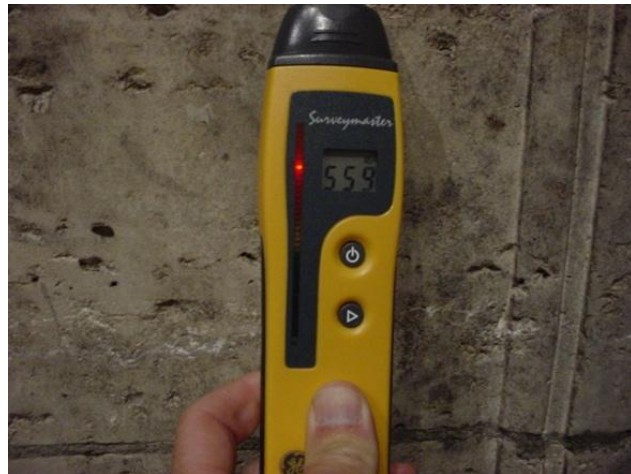
Photo 4

visit we noted that some of the western columns were moist (**Photo 4**); however, all of the columns were cold in comparison to the indoor ambient temperature.

Any moisture, absorbed on the exterior of the columns, will move to the opposite side of the column in the interior of the building by molecular diffusion and will eventually evaporate inside. Another possible source of indoor column moisture could be a result of condensation occurring on the face of the columns. This occurs when the indoor environmental conditions of temperature and Relative Humidity (RH) interact with the cold surface temperature of the columns. **Photos 5 & 6** are infrared images of the same area as **Photo 1**. The image shows nearly a 10 degree Celsius (dark blue to purple areas are colder and yellow to orange are warmer) difference between the ambient temperature and the base of the column. At 50% RH, the temperature of the column base is close to the dew point on the day we inspected this area.

No matter the source, elevated moisture was detected in some of the columns, as well as in the wallboard that comes into contact with the west columns. We believe the moisture in the wallboard is being absorbed from the columns. The moist wallboard is susceptible for organic growth and as the moisture evaporates, this process may allow for the art to absorb said moisture from the wallboard.

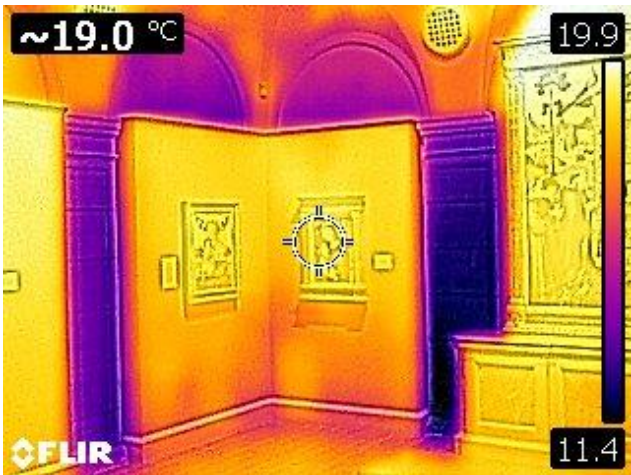
Photo 6

B. **Windows of the Sun Room and Villa** – Thermal imaging of the covered windows in the sunroom indicate there is little or no insulation and that no thermal break exists between the metal window frame and interior wallboard. The purple color of the window arches in **Photos 5 & 6** indicates a colder temperature than the surrounding area. The reverse is also evident in **Photo 7** on the east side of the sun room that is exposed to direct sunlight. In the thermal image you can see the metal framework of the window. Artwork attached to covered windows would be exposed to much larger temperature swings than artwork not attached to covered windows. **Photo 8** is of artwork attached to the wallboard covering an east, upstairs window located in direct sunlight. You can see the significant temperature and thermal radiation difference the two side by side artworks are experiencing. This environment may be impacting the stability of the artwork. These issues should be evaluated by an art expert for further consideration.

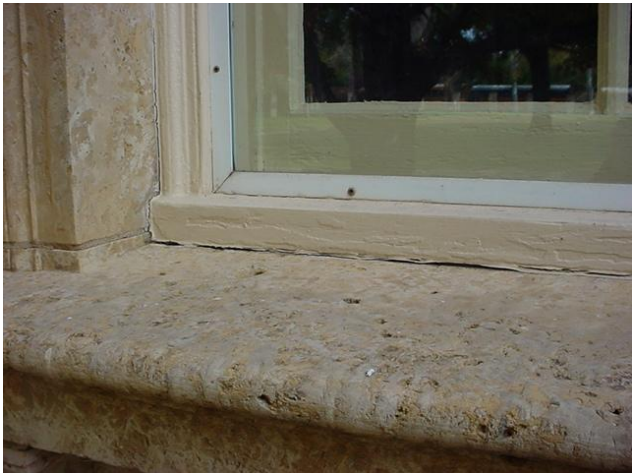
Photo 9

All wood windows should be inspected for air gaps and paint (**Photo 9**). All wood windows should be inspected for defects on a quarterly basis, as part as part of a building preventive maintenance system.

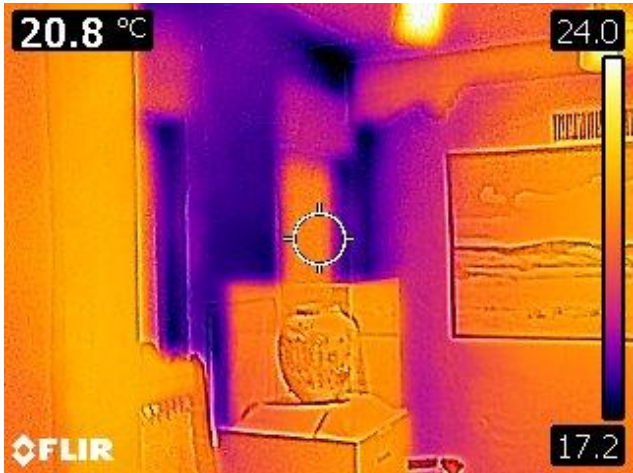
Photo 10

While this room was not directly part of the sustainability study goals, we noted an active leak in the NE corner of the Santa Fe Room as noted in **Photo 10**. The very dark blue in the corner of the room appears to be an active leak in the building exterior. This moisture was identified with the hand held moisture detector. Further investigation of this issue should be conducted and may be impacting art in this area of the museum.

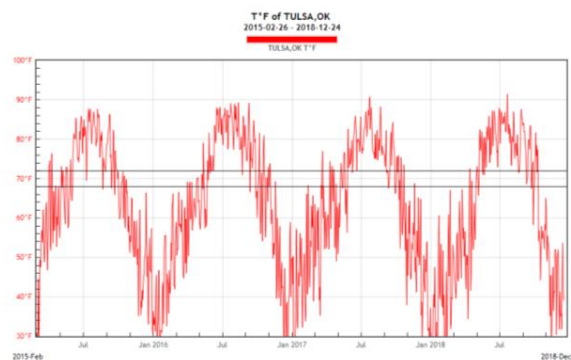
*Tulsa temperature 02/2015 – 12/2018*

*The black bands in the middle of each graph indicate the range generally considered safe for collections showing how far removed the exterior conditions are from desired.*

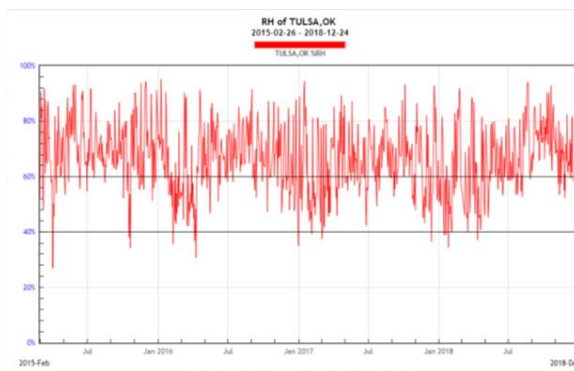
*Tulsa RH 02/2015 – 12/2018*

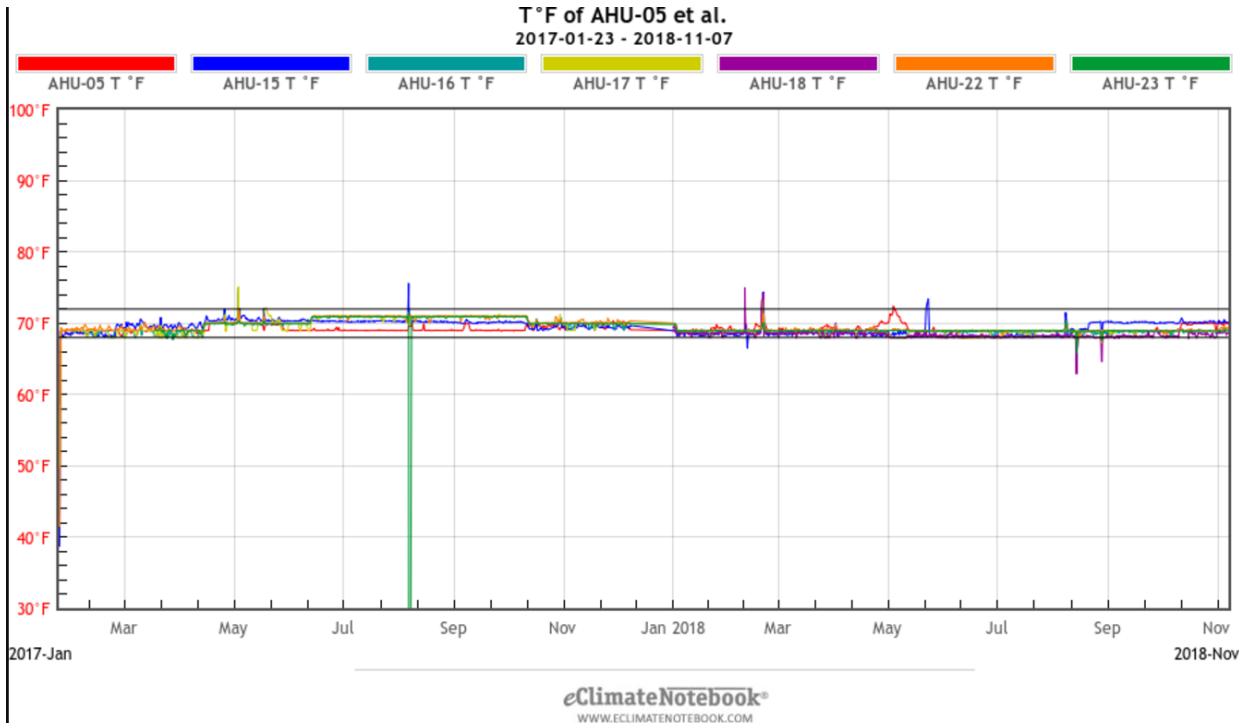
Temperature readings for several spaces on the Lower and Upper floors. Note that the temperature generally falls within the horizontal black bands representing 68-72 degrees F.

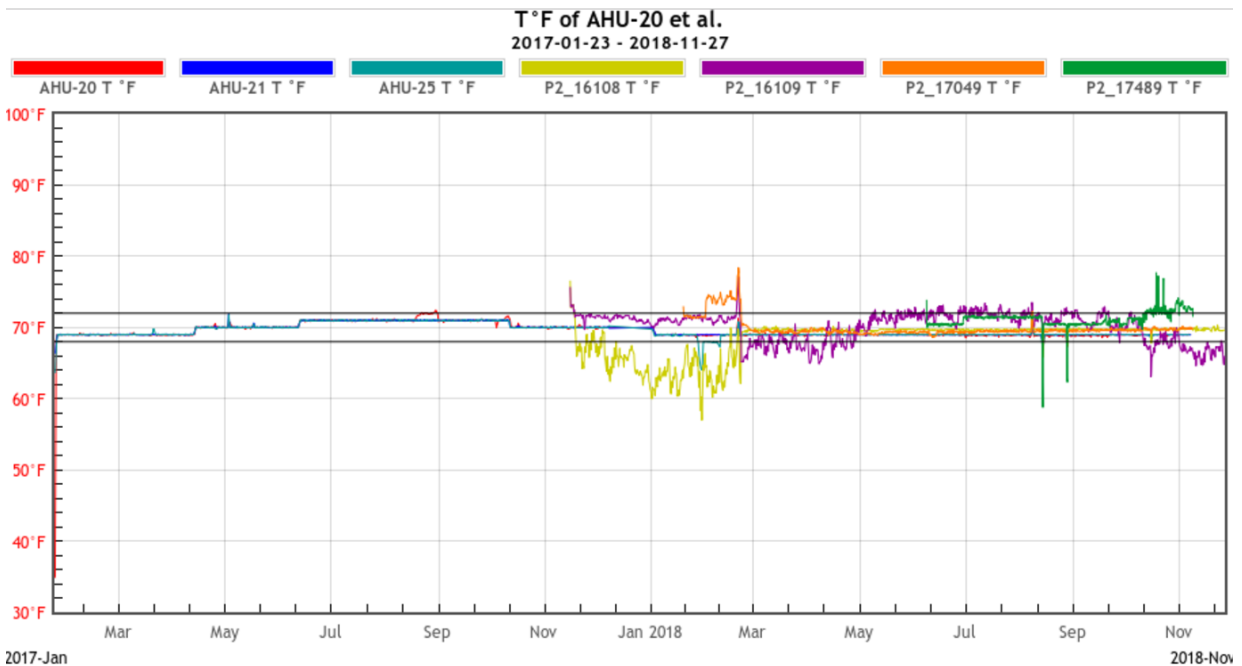
Temperature readings for several spaces on the main floor. Note that the Kress gallery spaces are more variable than other galleries and more frequently exceed the range of the black bands representing 68-72 degrees F.

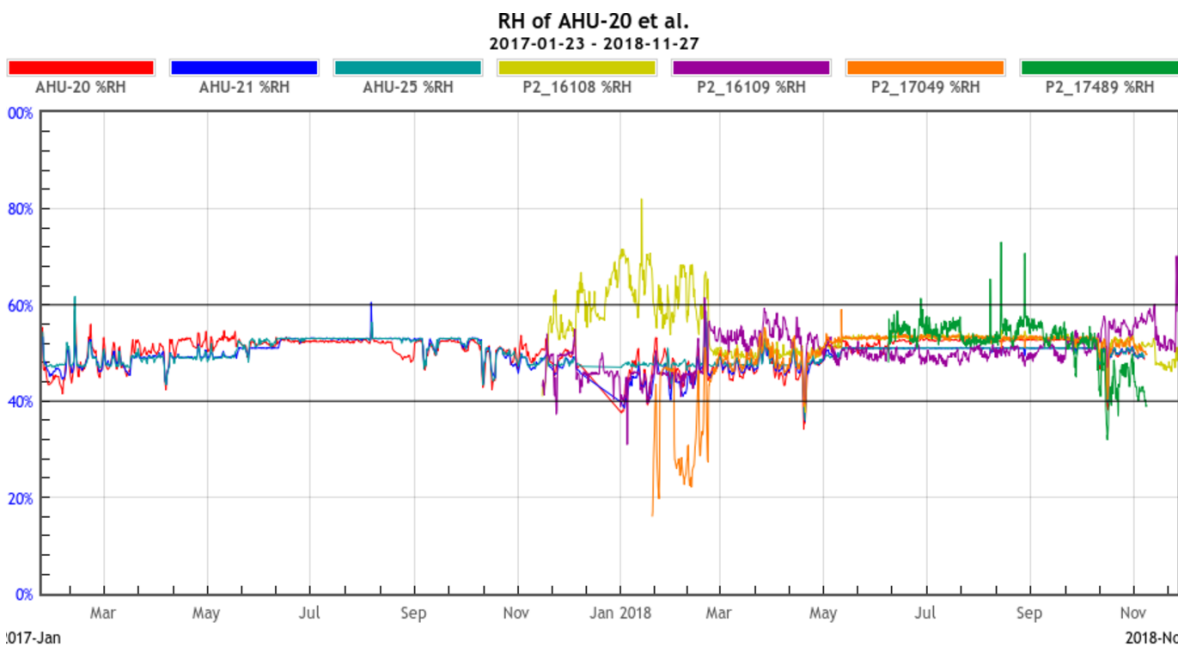
Relative humidity readings for several spaces on the main floor. The Kress gallery spaces are more variable than other galleries and the PEM2 data shows greater variability than the BMS sensor data. The PEM2 data is presumably more akin to what the collections “feel”. In this graph the desired RH range is shown as 40-60%.

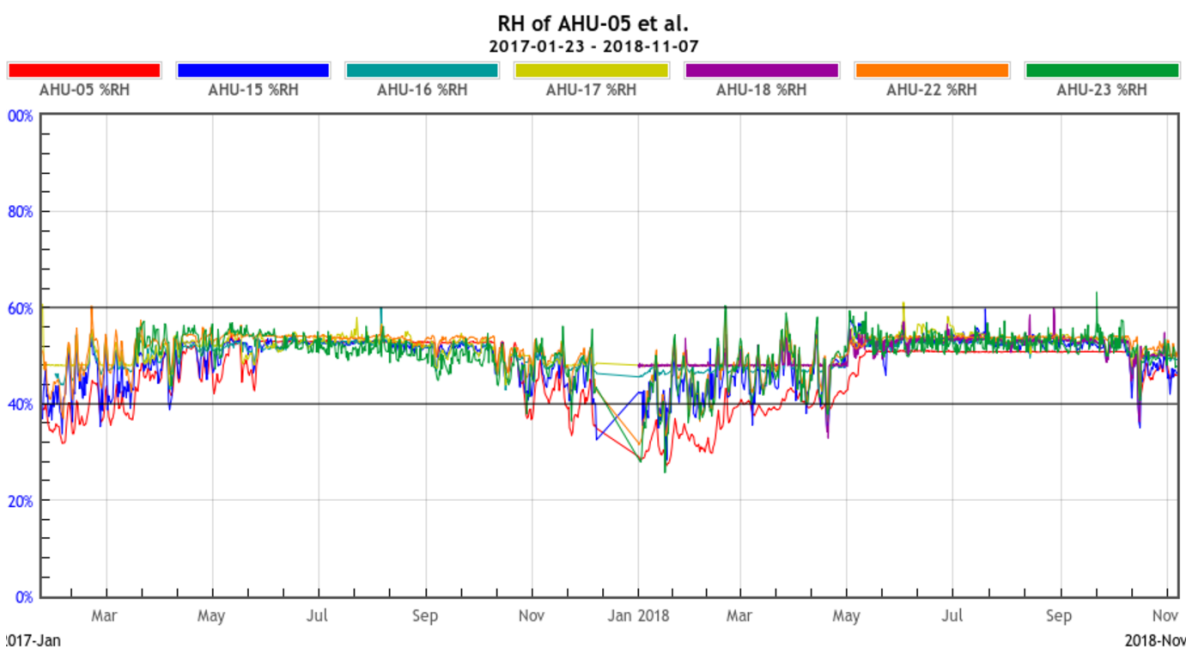
RH readings for several galleries on the upper and lower floors. For the most part the RH is within an acceptable range of 40-60% RH. The period of greatest concern is November to April when the RH in some spaces shows a sustained drop below 40%. But generally this low RH doesn't drop too much below 30% and so could still be considered safe for some materials. *N.B. the strange appearance of the data trends around December 2017 represents a period of missing data.*

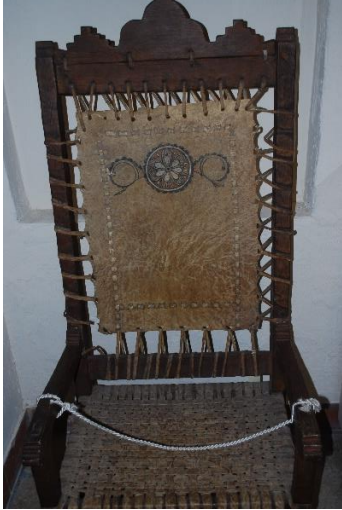
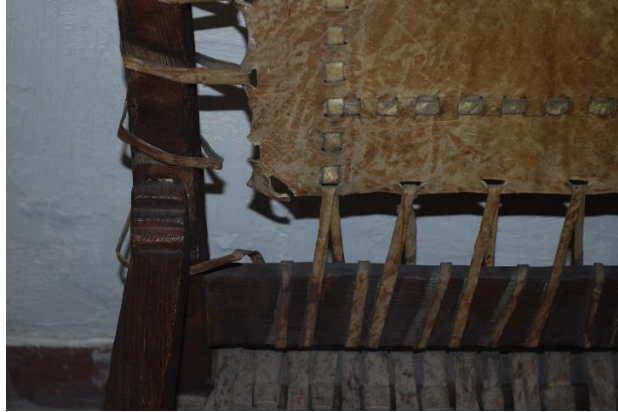
*Chair with stretched hide (overall on left) showing splits and tears possibly (detail on right)*

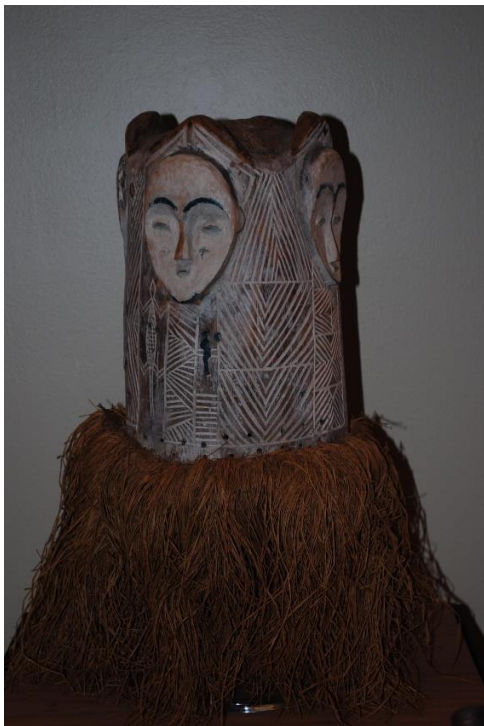
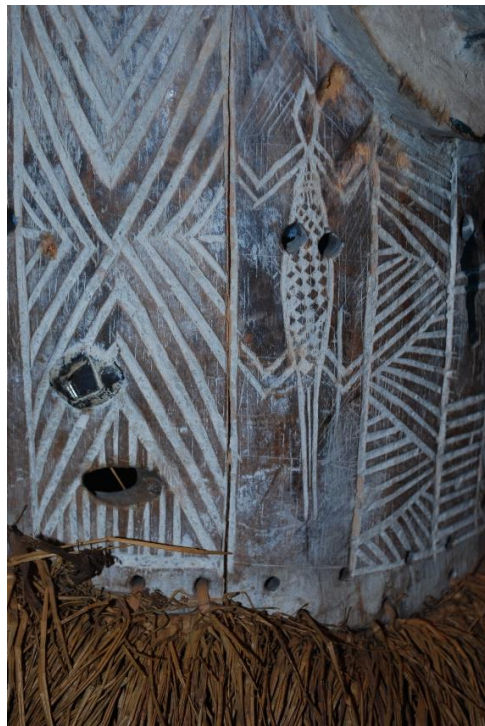
*African headdress with radial splits in the wood*

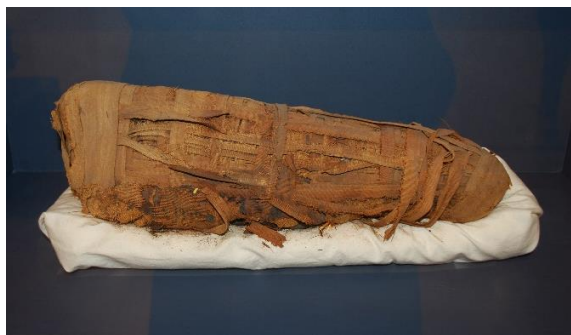
*Deteriorating linen mummy bundle wrappings*

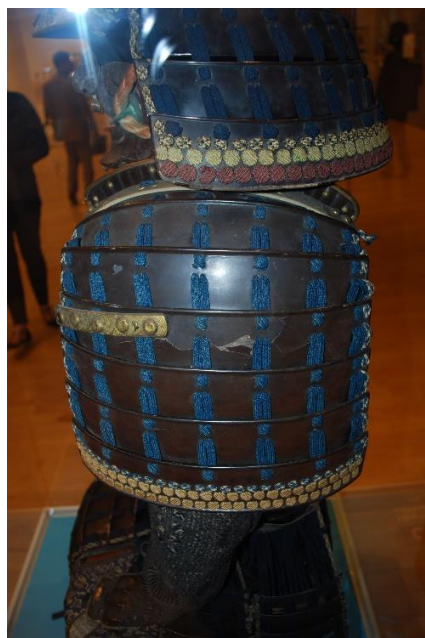
*Cracking and loss of lacquer surface*

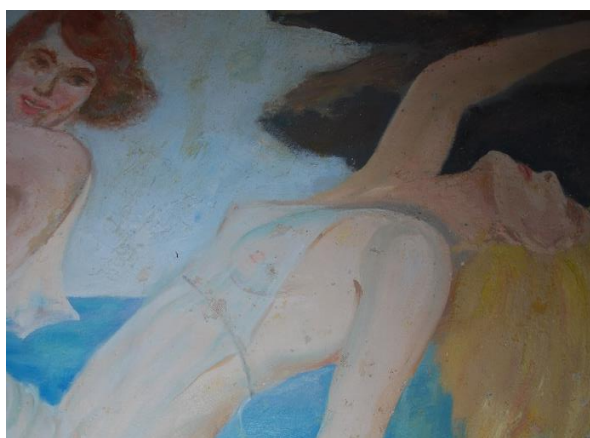
*Loss of surface on painted wall - main floor*

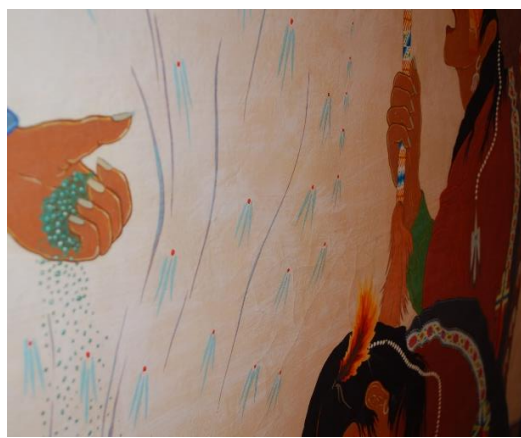
*Cracking and tenting of painted surface – lower level*

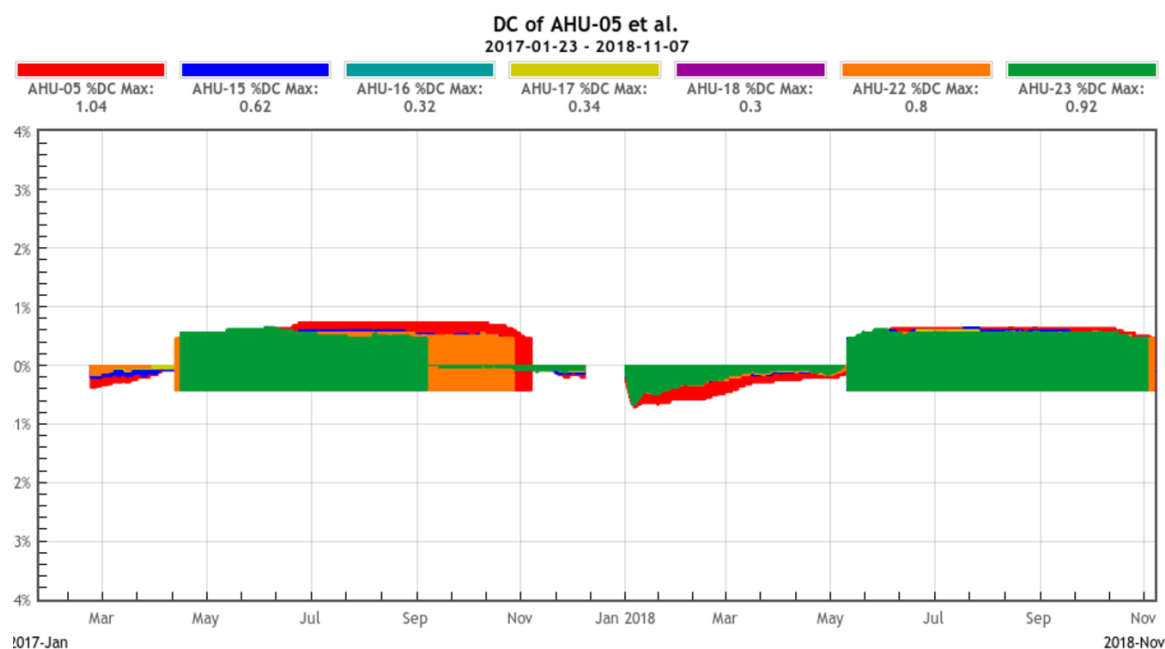
% Dimensional change metric for selected upper and lower floor galleries

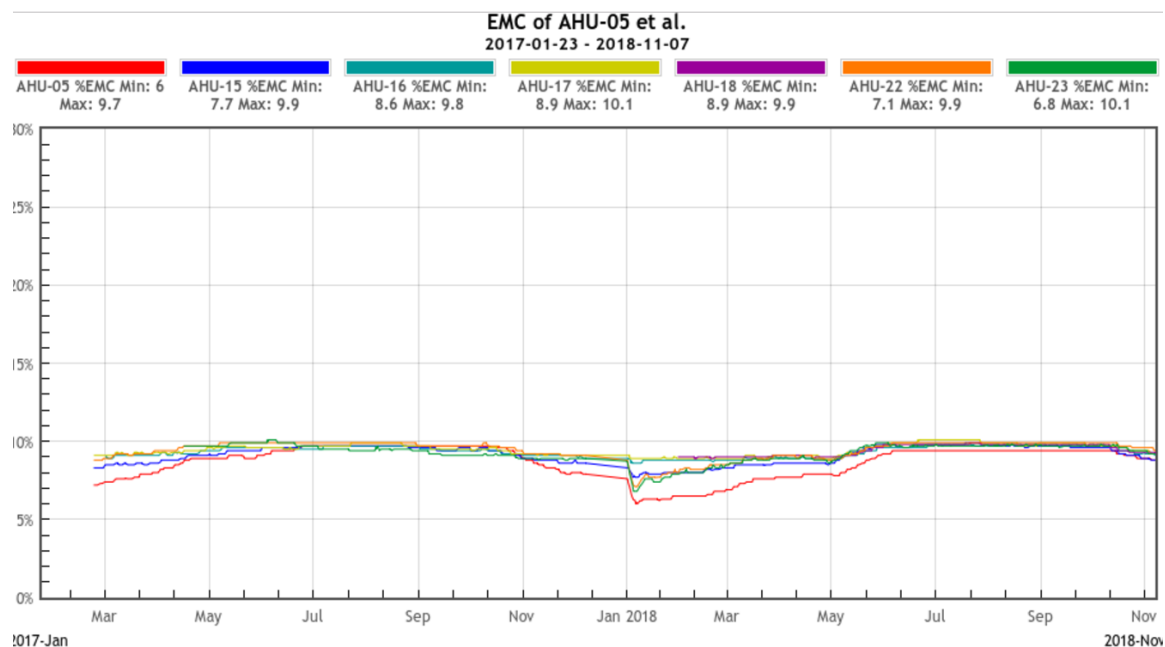
% Equilibrium Moisture Content metric for selected upper and lower floor galleries

Excursions above 55 were short in duration and not likely to cause damage. The sustained excursions below 40% RH in the winter might not be a problem assuming that the collection has acclimated to drier conditions. Depending on energy savings and implications for the building envelope the 40-60% RH or, 35-55% RH ranges could be used.

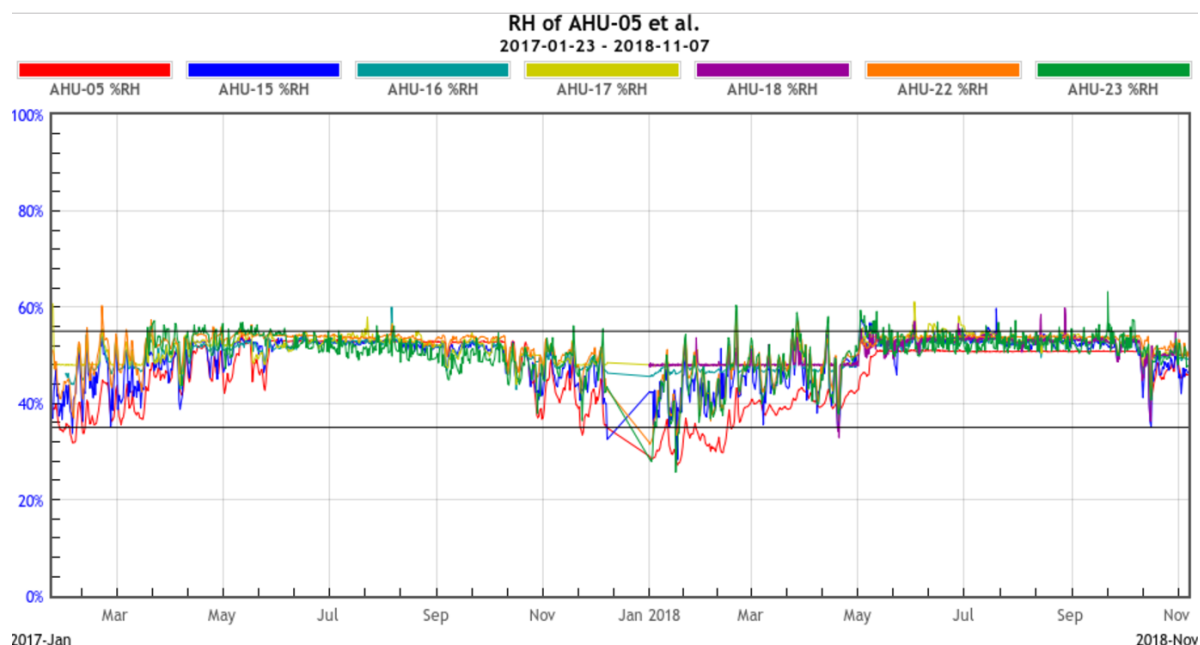
Upper and lower floor galleries graphed with the bands of 35-55% RH indicating that the current system is able to achieve these conditions in most spaces.
